UNDERWATER BRIDGE INSPECTION REPORT

STRUCTURE NO. 56507

OTTER TAIL RIVER

MINNESOTA DEPARTMENT OF TRANSPORTATION
UNDERWATER BRIDGE INSPECTION

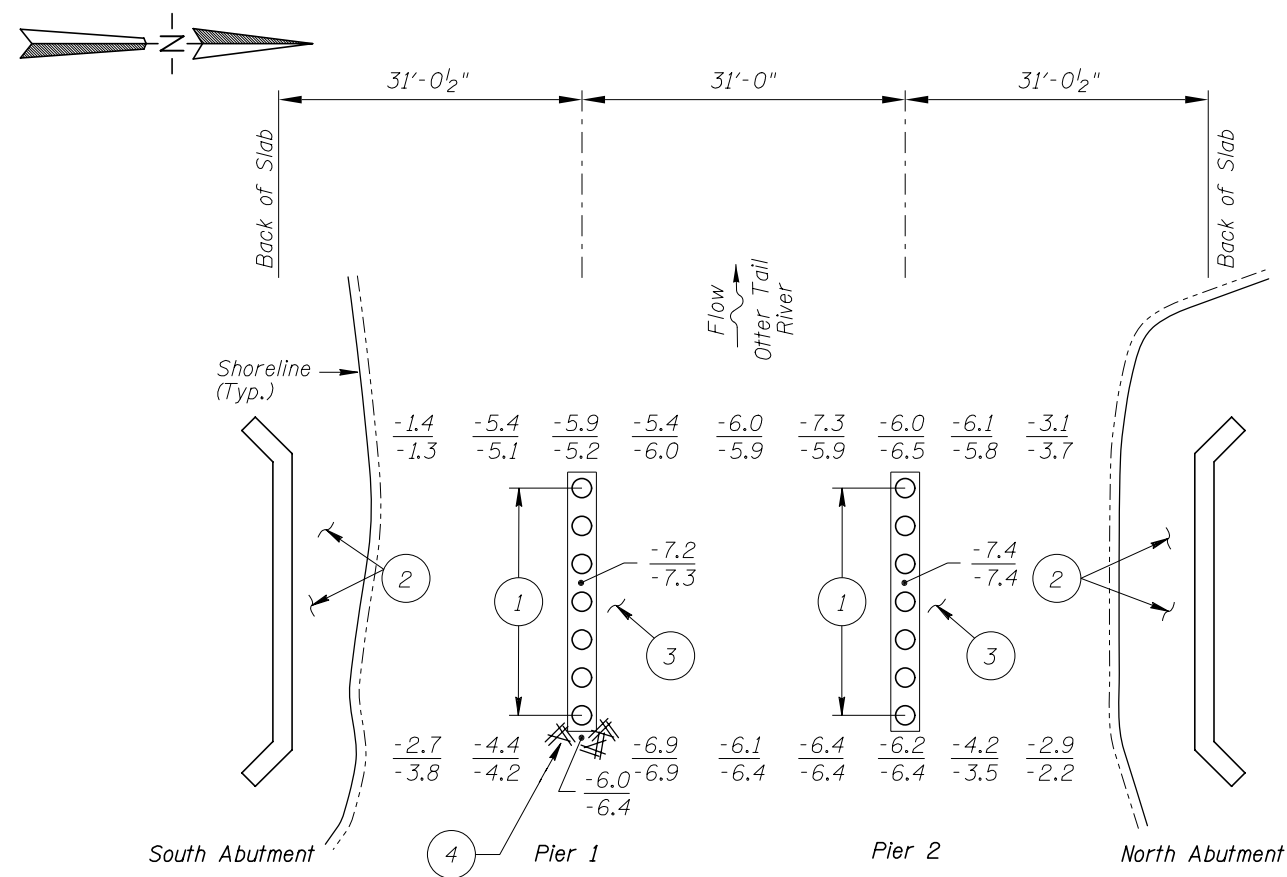
INSPECTION AND SOUNDING PLAN

- Overall, approximately 50 percent of the total surface area of the steel pipe piles surfaces exhibited coating failure and minor corrosion with pitting up to 1/32 inch deep.
- 1 to 3 foot diameter riprap armored both shorelines.
- The channel bottom material consisted of gravel, sand, and random riprap with a maximum probe rod penetration of 6 inches.
- A light accumulation of timber debris consisting of 2 inch diameter and smaller branches was observed at the upstream pile of pier 1 extending from channel bottom up to the waterline and radiating 3 feet out from pile.
